**Flood Control Project Maintenance
Levee Inspections**

Maintenance Issue Types Only, Levee Inspection Report By Mile - Spring 2019

Reclamation District No. 2089 Stark

Waterway	Bank	Unit Miles	Inspection Start/End	Inspector
Unit No. 01 Old River	Right	1.51	04/04/2019 04/04/2019	Alberto De Leon

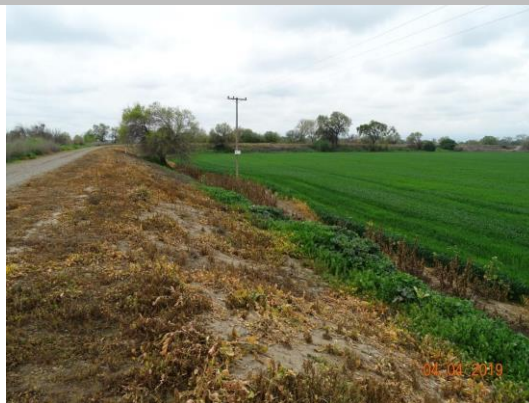
Photo 1 of 1 : SP_2019_RD2089_316_27_20190422_00057.jpg

LM Start	0.83	Rating **	U	Issue No.	27
LM End	1.51	Issue Type +	Ma	Location *	LS
Category	Earthen Levee			GPS Latitude/Longitude	
				Start	End
Item	Vegetation			37.807991 °	37.806638 °
				-121.397847 °	-121.407833 °
DWR ID	DWR_RD2089_01_s_2019_27				
Comment Code					
V2 : Remove the wild growth other than native grasses from the levee slopes.					
Inspector Comment					
Vegetation on landside toe needs to be maintained to allow access and visibility.

View of vegetation on landside slope. (spring 2019)

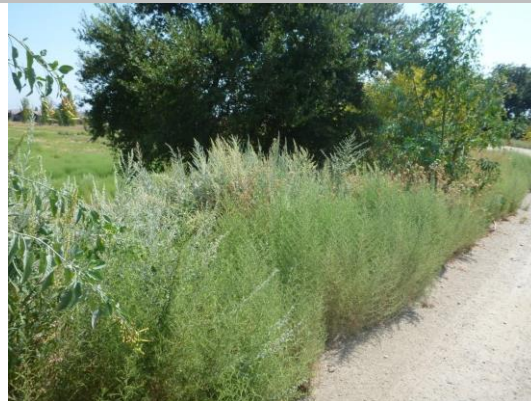
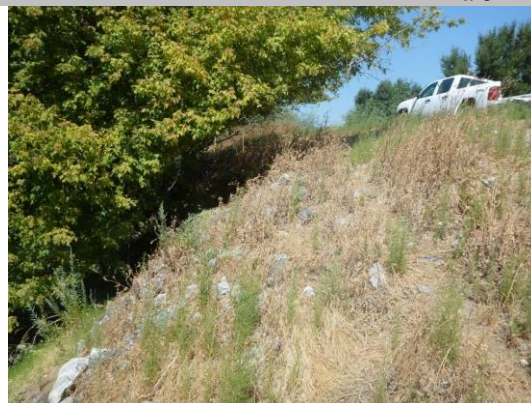
LM Start	0.39	Rating **	A/W	Issue No.	50
LM End	0.41	Issue Type +	Ma	Location *	
Category	Supplemental			GPS Latitude/Longitude	
				Start	End
Item	2017 Storm Damage			37.810150 °	37.810270 °
				-121.412930 °	-121.413240 °
DWR ID	DWR_RD2089_02_f _ 2017_50				
Comment Code					
Inspector Comment					
Levee Evaluation Comments					
Description:Slope protection repairs are needed along the waterside slope due to erosion and riprap displacement from high water. Based upon levee inspections, it was determined the waterside levee slope is eroding, deteriorating, and degrading. The eroded levee sections need to be restored back to design standards to prevent further deterioration and damage.					
Site ID No:508					
Site Designation:LMA-414					
Repair Type: Erosion					
Rating:Serious					
Field Date:8/16/2017					
Notes: Large erosion around tree with a 12' vertical cut.

Comment Code						
Inspector Comment						
Levee Evaluation Comments						
Description:Slope protection repairs are needed along the waterside slope due to erosion and riprap displacement from high water. Based upon levee inspections, it was determined the waterside levee slope is eroding, deteriorating, and degrading. The eroded levee sections need to be restored back to design standards to prevent further deterioration and damage.						
Site ID No:508						
Site Designation:LMA-414						
Repair Type: Erosion						
Rating:Serious						
Field Date:8/16/2017						
Notes: Large erosion around tree with a 12' vertical cut.

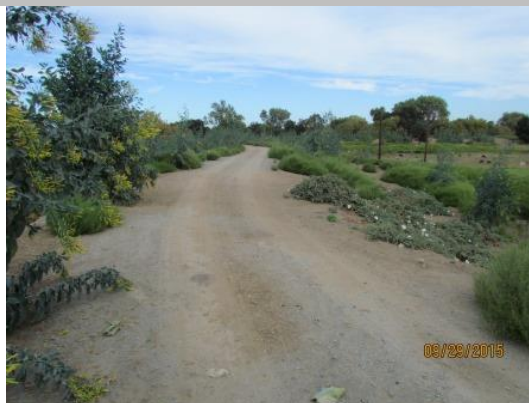
Photo 2 of 4 : SP_2019_RD2089_317_35_20190313_00034.jpg

View of the levee crown depression looking downstream.

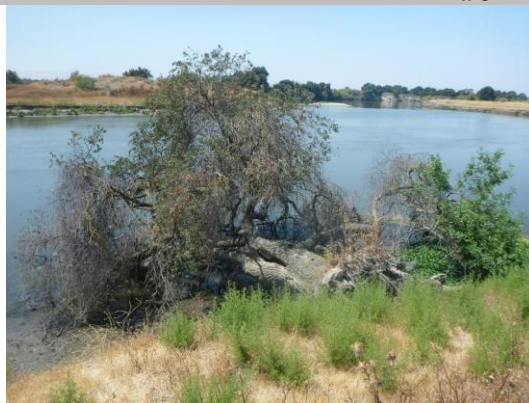
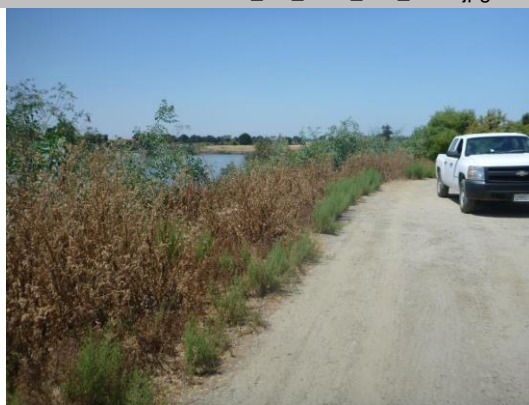
LM Start	0.60	Rating **	A/W	Issue No.	56 (cont)	
LM End	0.61	Issue Type +	Ma	Location *		
Category	Supplemental			GPS Latitude/Longitude		
				Start		End
Item	2017 Storm Damage			37.812000 °		37.812100 °
				-121.415700 °		-121.415900 °
DWR ID	DWR_RD2089_02_s_2018_56					
Comment Code						
Inspector Comment						
Levee Evaluation Comments						
Description:Slope protection repairs are needed along the waterside slope due to erosion and riprap displacement from high water. Based upon levee inspections, it was determined the waterside levee slope is eroding, deteriorating, and degrading. The eroded levee sections need to be restored back to design standards to prevent further deterioration and damage.						
Site ID No:507						
Site Designation:LMA-413						
Repair Type: Erosion						
Rating:Serious						
Field Date:8/16/2017						
Notes: Vertical cut on outside bend of river

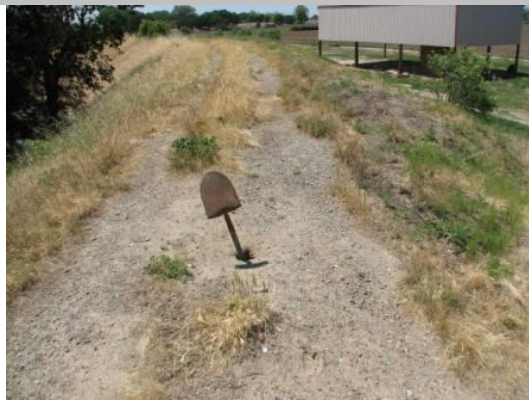
Photo 2 of 3 : SP_2019_RD2089_317_40_20190313_00039.jpg

LM Start	0.85	Rating **	U	Issue No.	40 (cont)
LM End	0.90	Issue Type +	Ma	Location *	LS
Category	Earthen Levee			GPS Latitude/Longitude	
				Start	End
Item	Animal Control			37.814997 °	37.814970 °
				-121.414774 °	-121.415767 °
DWR ID	DWR_RD2089_02_s_2012_40				
Comment Code					
A1 : Exterminate rodents and backfill and compact or grout burrows.					
Inspector Comment					
Numerous burrows are on the landside slope adjacent to the hay storage area. Deep burrows are in the crown and landside ramp.

View of deep vertical burrow in levee crown. 05/24/2011

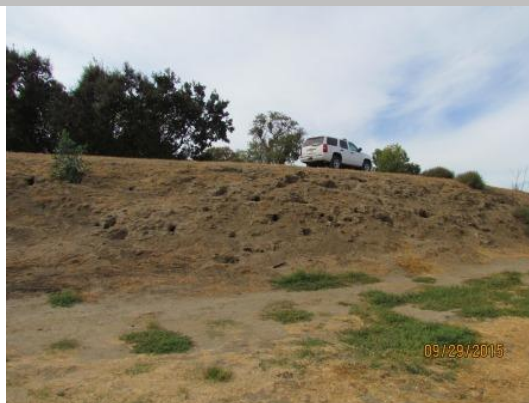
Photo 3 of 3 : SP_2019_RD2089_317_40_20190313_00040.jpg

View of the multiple rodent holes on the landside levee slope.

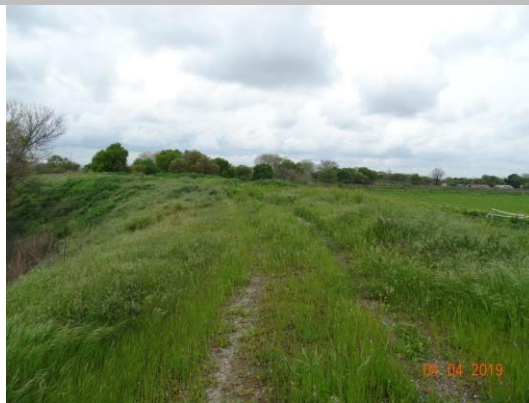
Photo 1 of 1 : SP_2019_RD2089_317_36_20190422_00071.jpg

LM Start	0.86	Rating **	U	Issue No.	36
LM End	1.34	Issue Type +	Ma	Location *	CR
Category	Earthen Levee			GPS Latitude/Longitude	
				Start	End
Item	Vegetation			37.815032 °	37.819556 °
				-121.414982 °	-121.419621 °
DWR ID	DWR_RD2089_02_s_2019_36				
Comment Code					
V9 : Keep the crown roadway free of vegetation.					
Inspector Comment

View of vegetation on levee crown. (Spring 2019)
